LARKIN PROPERTY INSPECTION AND MANAGEMENT, LLC

RESIDENTIAL INSPECTION

Sample Report Manchester VT 05254

DECEMBER 8, 2021

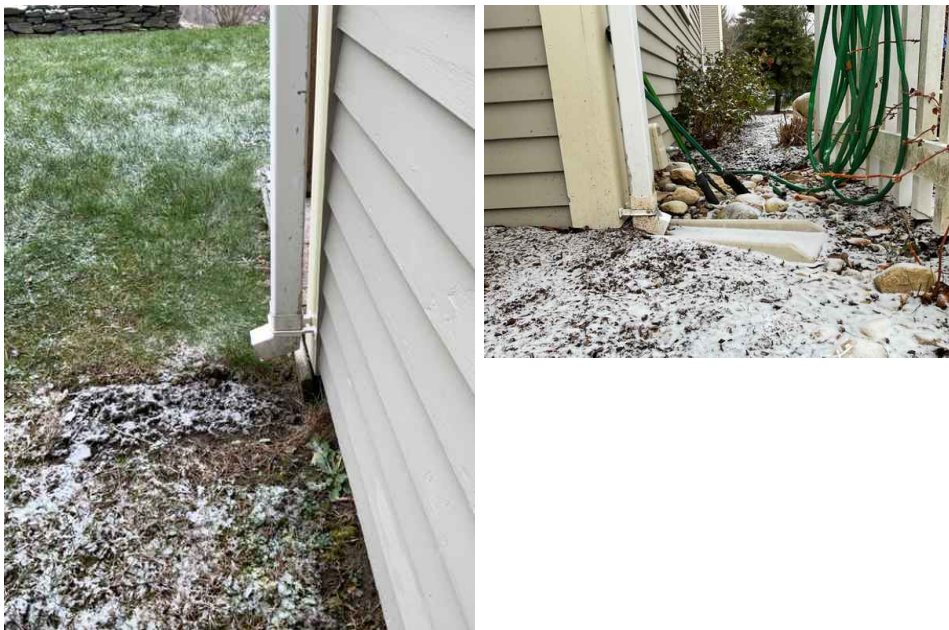
2.4.1 Roof Drainage System

— Moderate Concern/Repair**DOWNSPOUTS: DISCHARGE TO FOUNDATION- QC**

One or more downspouts discharged roof drainage next to the foundation. This condition can result in high moisture levels in soil at the foundation that can cause damage related to soil/foundation movement. Downspout extensions should be installed to discharge roof drainage away from the foundation.

Contact a qualified gutter contractor

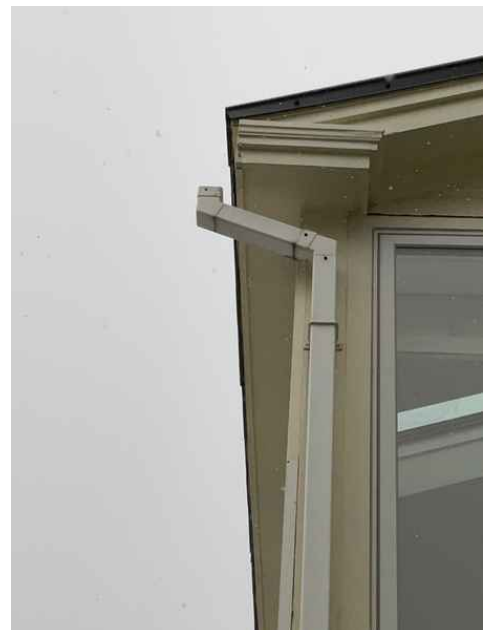
2.4.2 Roof Drainage System

— Moderate Concern/Repair**GUTTERS: DISCONNECTED (LONG)- QC**

One or more gutter sections needed to be re-connected in order to properly control roof run-off. This condition can result in excessively high moisture levels in soil at the foundation. Excessive moisture levels in soil near the foundation can affect the ability of the soil to support the weight of the structure above and can cause damage related to soil/foundation movement. Repairs should be made as necessary by a qualified contractor.

Contact a qualified professional.

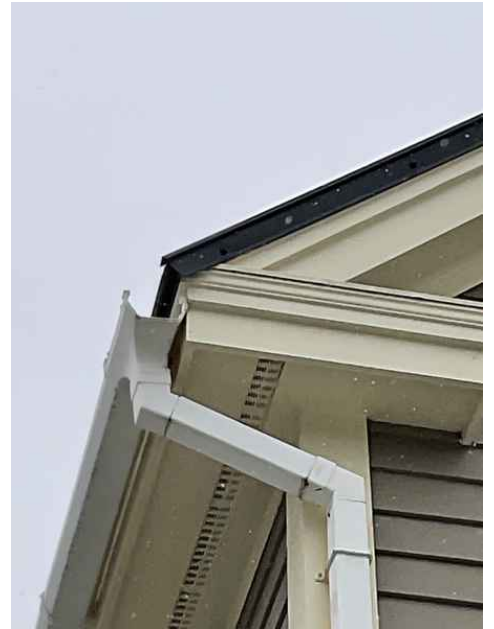
2.4.3 Roof Drainage System

**GUTTERS: END CAPS, MISSING-
QC**

Some gutters were missing end caps. This condition can result in excessively high moisture levels in soil near the foundation that can cause damage related to soil/foundation movement. Missing end caps should be replaced.

Contact a qualified professional.

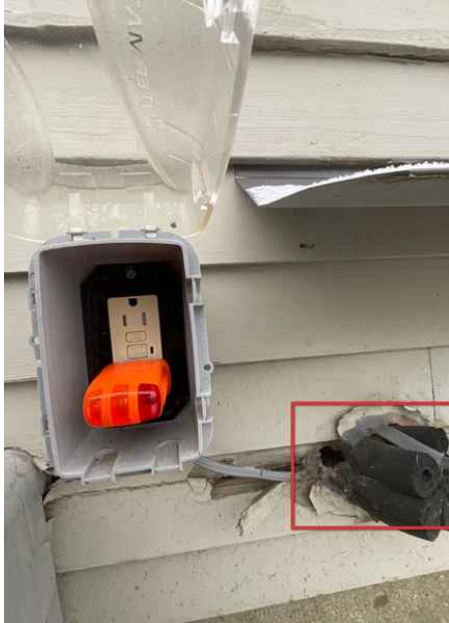
Hole in exterior siding was observed. This will allow heat and cooling loss as well as insects and small animals. Recommend a professional contractor to repair this area.

Hole in exterior siding.

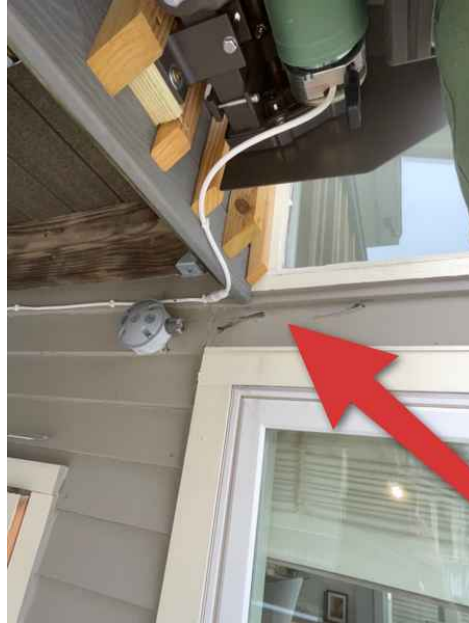
small paint chipping above exterior window on deck. Recommend a professional painter to touch up this area when the weather improves for exterior applications.

Minor paint chipping

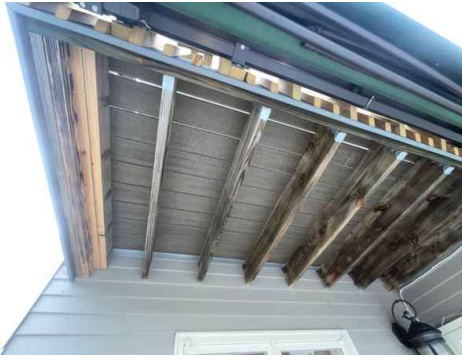
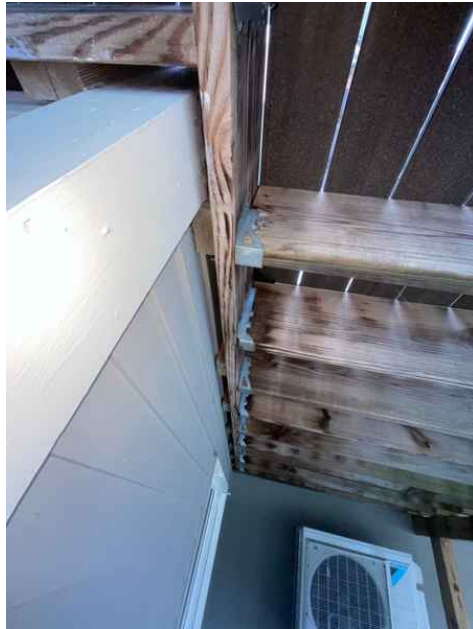
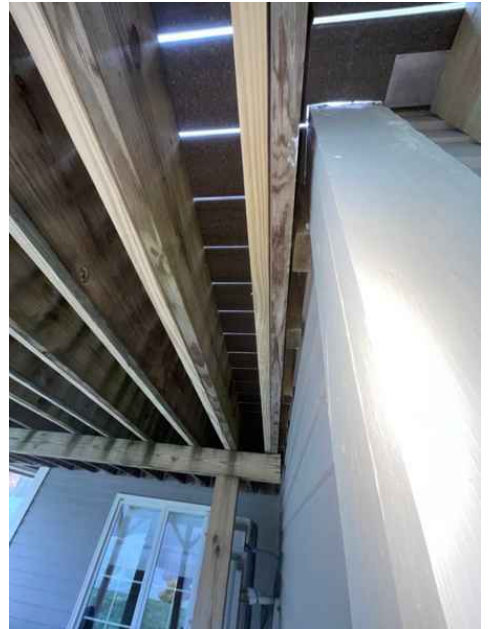
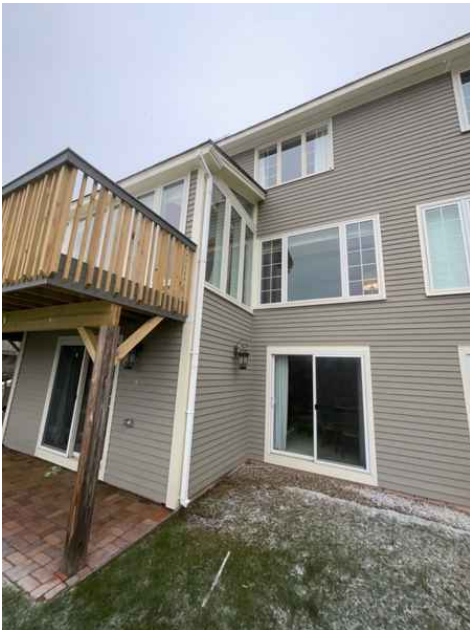
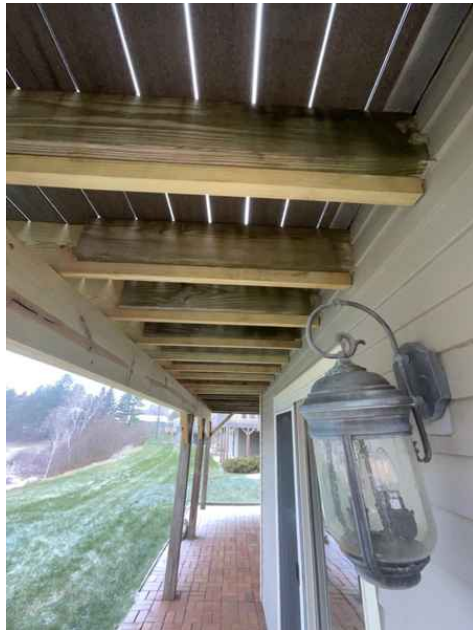
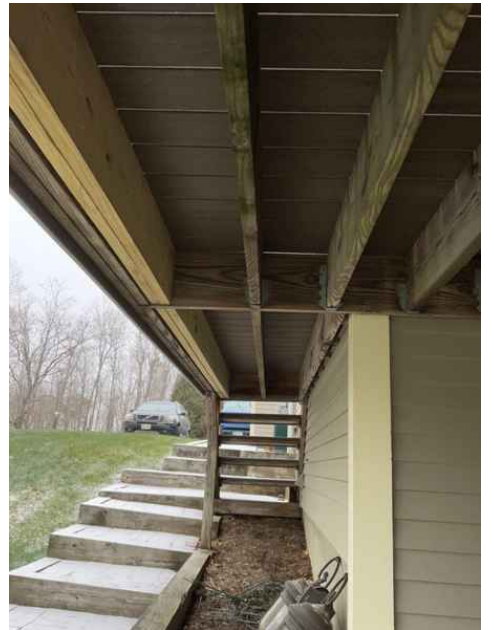
5.5.1 Deck

ATTACHMENT: INADEQUATE HARDWARE- QC

Moderate Concern/Repair

The hardware attaching the deck to the home appeared to be inadequate in some places. The existing deck was attached to the condominium with joists that extended from the condo interior to the exterior as the main support for the deck flooring. A larger deck was installed and the existing joists were extended outward to make the deck area wider as well as longer. The deck connection to the condo not supported by the existing floor joists appears to be nailed rather than attaching a ledger board and through bolts to secure the remaining deck structure to the exterior. Although no failure was visible at the time of the inspection that in the Inspector's experience could be attributed to this condition, the Inspector recommends having a qualified contractor evaluate the deck for proper connection to the exterior.

Contact a qualified carpenter.

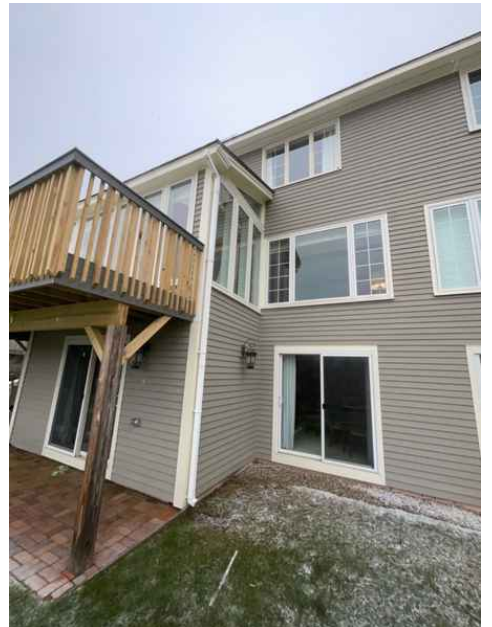
5.5.2 Deck

GUARDRAILS: LACK OF GUARDRAIL POSTS - QC

Serious Concern/Action Needed

Posts supporting deck guardrail assemblies were not installed. Although physical testing using specialized measurement devices lies beyond the scope of the General Home Inspection, the lack of guardrail posts appeared to be structurally inadequate as fall protection. The Inspector recommends correction by a qualified contractor.

Guardrails should be supported by posts every 6 feet.

Recommendation
Contact a qualified carpenter.

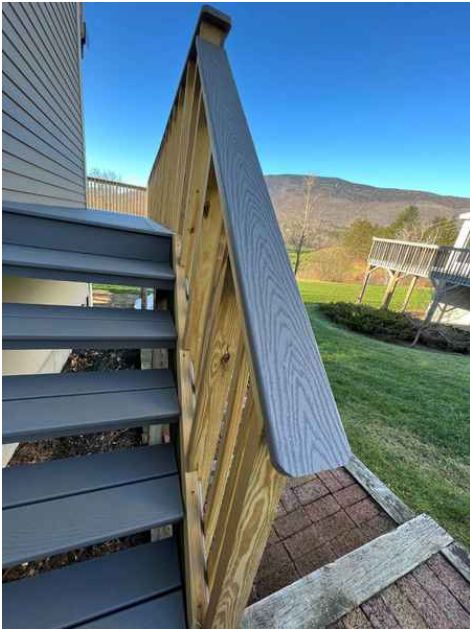
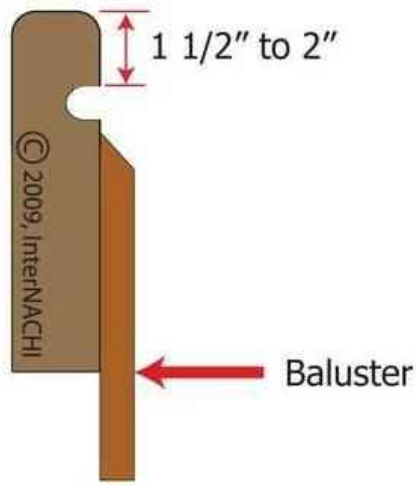
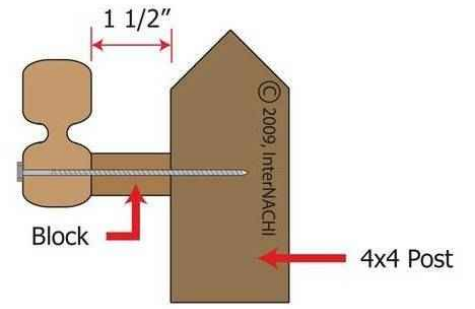
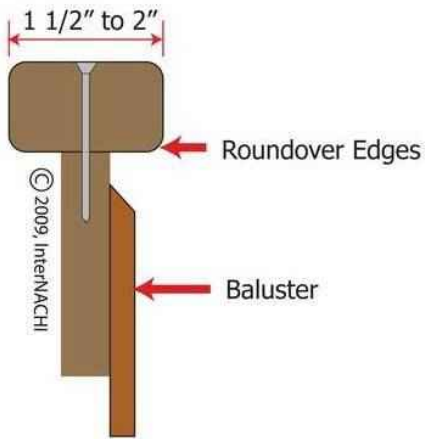
5.5.3 Deck

STAIR HANDRAIL: NON GRASPABLE HANDRAIL

Moderate Concern/Repair

This deck staircase did not meet generally-accepted modern safety standards for the proper the size and dimensions of a graspable handrail. Recommend installing graspable handrail by a professional contractor.

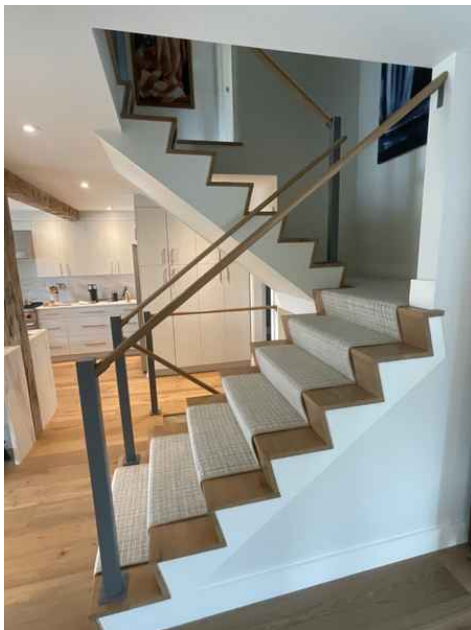
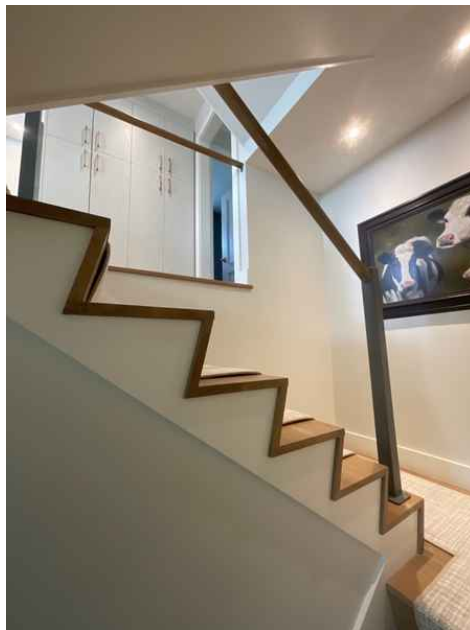
HANDRAIL ASSEMBLY: BALUSTERS MISSING- QC

The handrail assembly at this staircase was missing balusters. For safety reasons all missing balusters should be replaced by a qualified contractor.

Contact a qualified carpenter.
