LARKIN PROPERTY INSPECTION AND MANAGEMENT, LLC

RESIDENTIAL INSPECTION

Sample Report Manchester VT 05254

DECEMBER 8, 2021

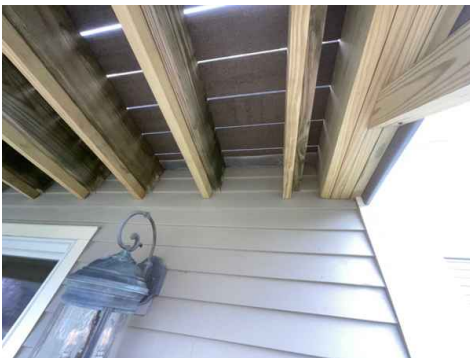
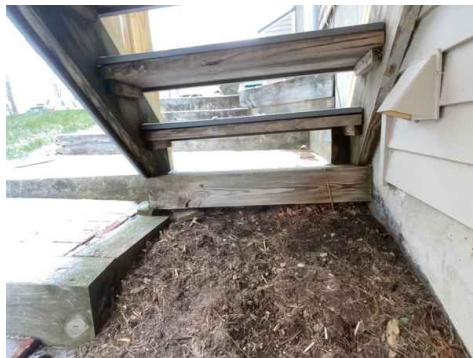
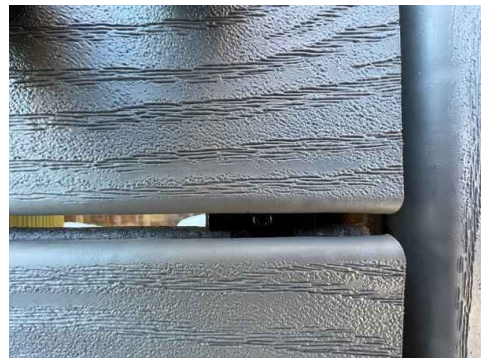
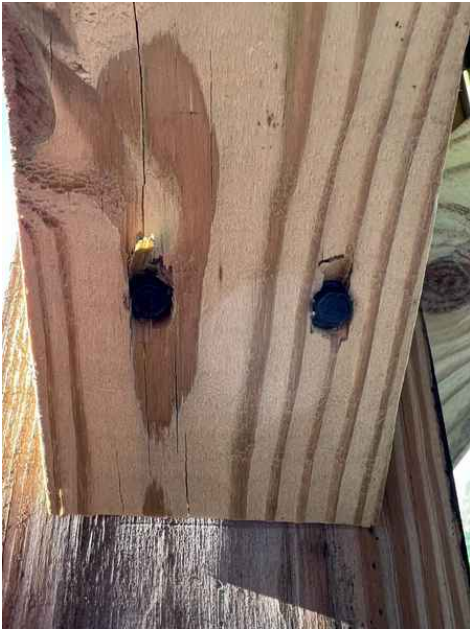
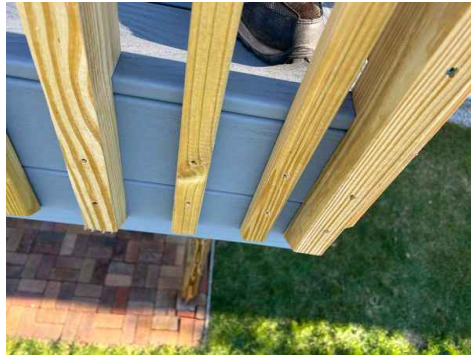
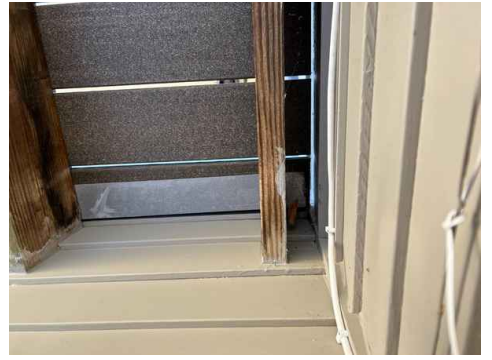
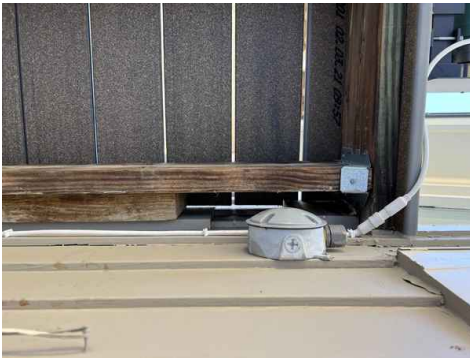
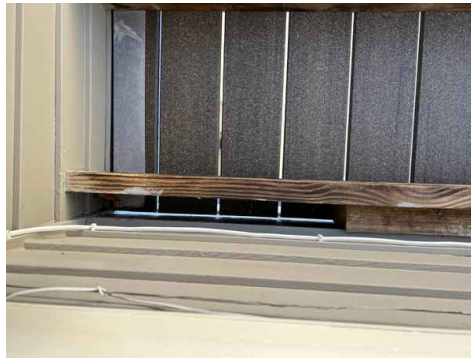
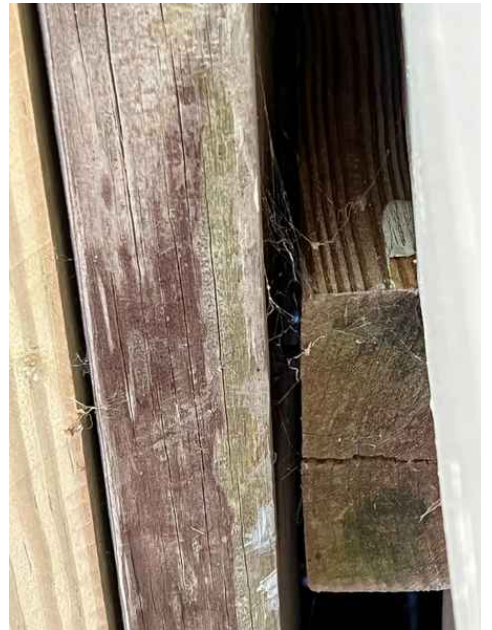
Hole in exterior siding was observed. This will allow heat and cooling loss as well as insects and small animals. Recommend a professional contractor to repair this area.

small paint chipping above exterior window on deck. Recommend a professional painter to touch up this area when the weather improves for exterior applications.

Contact a qualified carpenter.

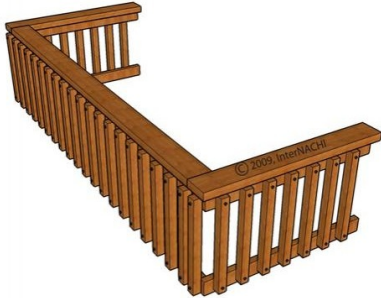
Posts supporting deck guardrail assemblies were not installed. Although physical testing using specialized measurement devices lies beyond the scope of the General Home Inspection, the lack of guardrail posts appeared to be structurally inadequate as fall protection. The Inspector recommends correction by a qualified contractor.

The image above shows a guardrail supported solely by balusters.

Guardrails should be supported by posts every 6 feet.

Recommendation
Contact a qualified carpenter.

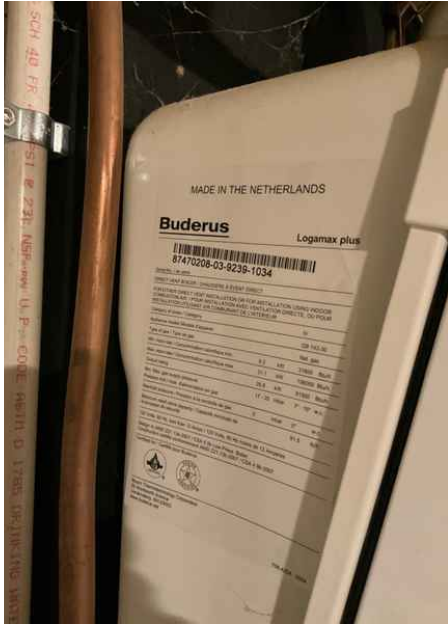
Boiler: Hydronic Heating: Data plate: photo

The photo shows information marked on the boiler label or data plate such as the manufacturer, model and serial numbers.

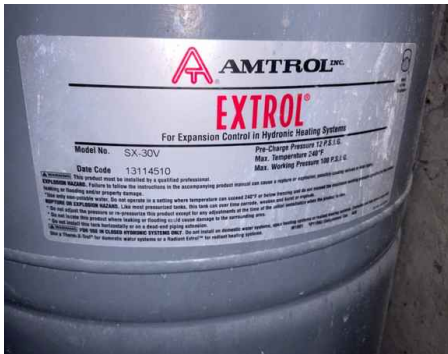
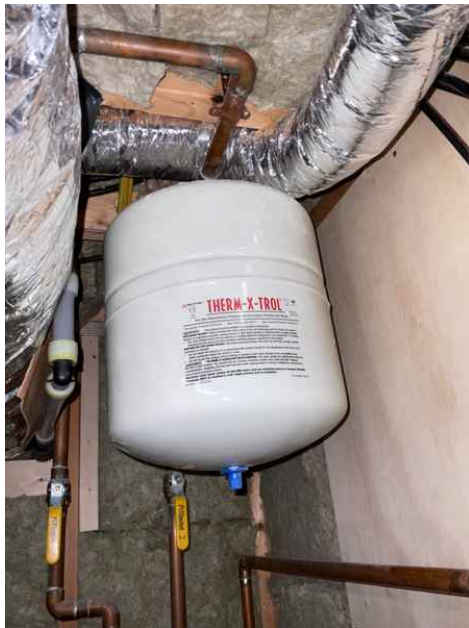
Boiler: Hydronic Heating: Expansion tank: installed

The boiler had an expansion tank installed to allow for thermal expansion of water in the plumbing pipes. The expansion tank appeared to be properly installed.

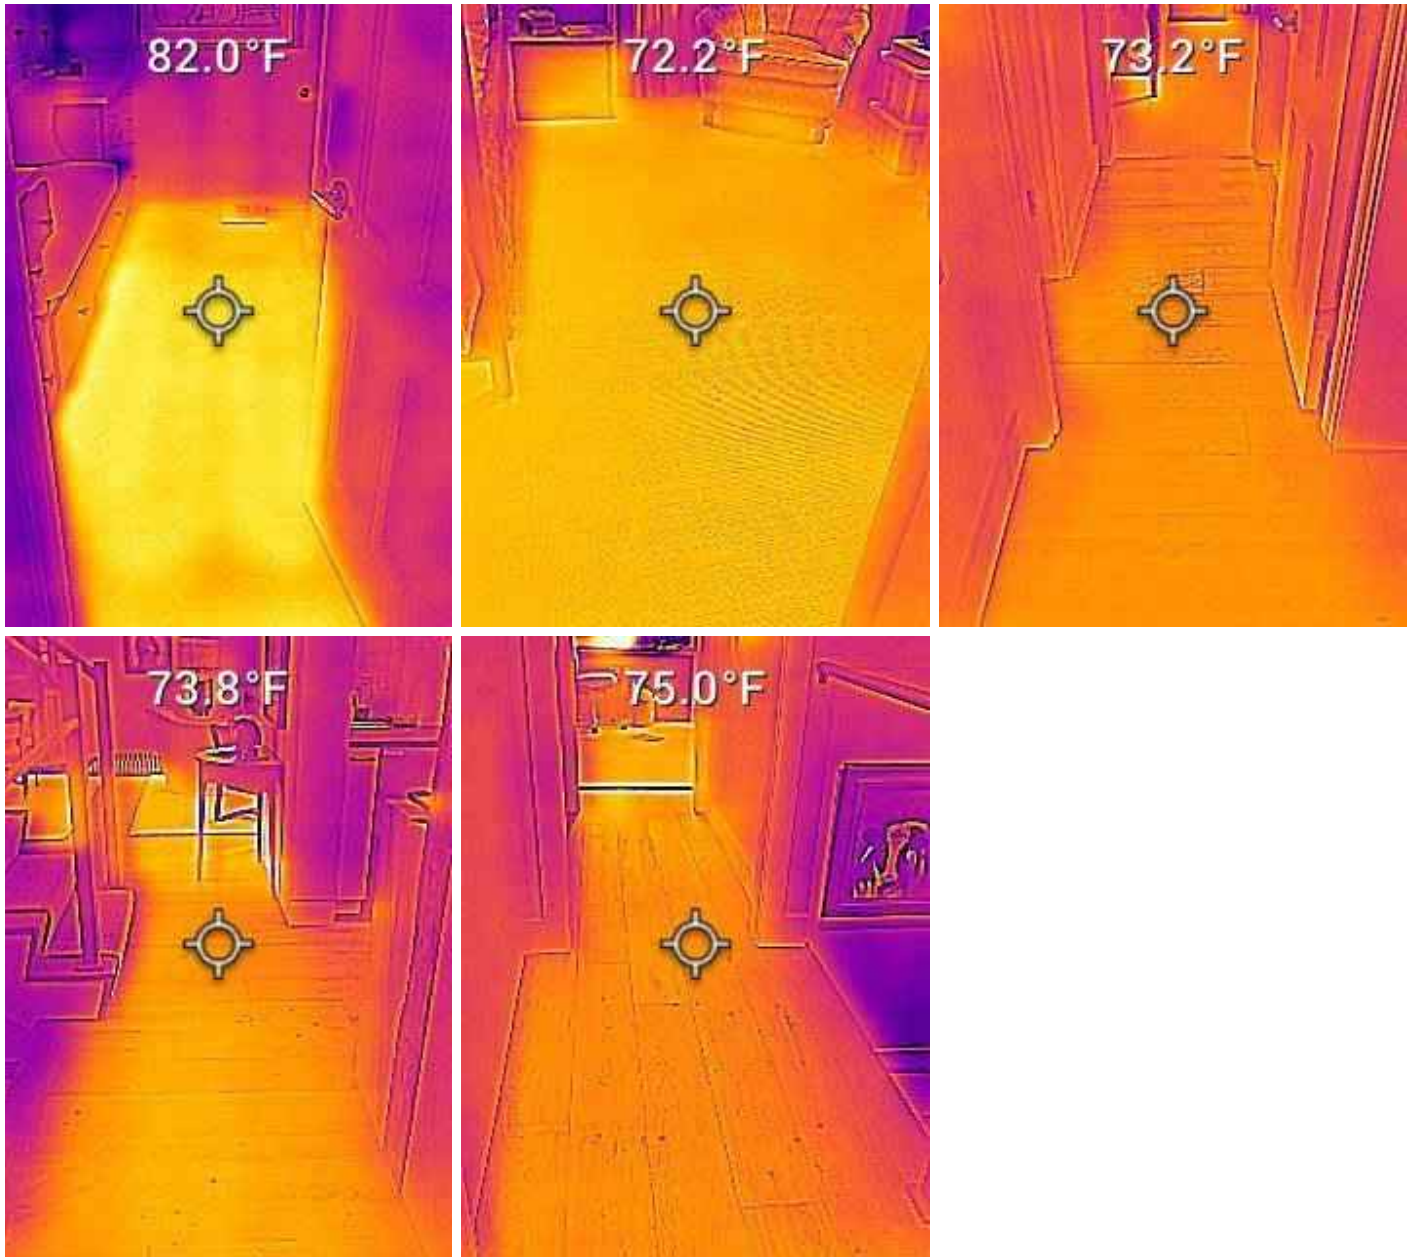
Boiler: Hydronic Heating: Radiant floor system installed

Home heat was distributed by fluid heated by the boiler and circulated through pipes installed in the floor structure. The circulation pipes radiate heat into the living space. This is called a "radiant in-floor" heating system.
